ExxonMobil Baytown Frame 6B Outer IGV Bushing Clearance

Frame 6B User Group Meeting June 25-28, 2012 Greg Polasek

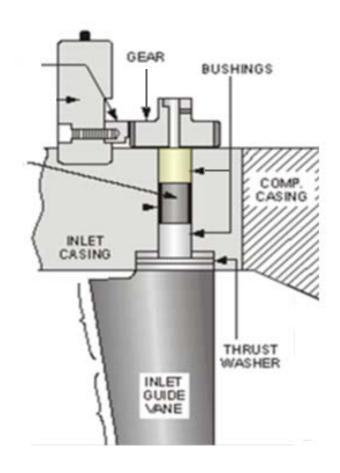
scheduled major inspection Fall 2011
- During IGV reassembly, mechanical first line supervisors note what appears to be excessive clearance in the newly assembled IGV (new bushings, gears, rack, IGV's)
- IGV shank OD measured, confirmed against GE drawings and in tolerance
- Outer bushings measured found too loose, confirmed against GE drawings and found to be out of tolerance when comparing required clearance (outer bushing ID to IGV shank OD)
- Verified outer bushing dimensions against GE supplier, found to be in tolerance to GE supplier drawings

- The original GE drawing indicated a clearance specification of 0.005" and the vendor drawing for the bushing, as calculated would indicate a clearance specification of 0.010".
- Bushing spec is an off the shelf/vendor catalog component
- PAC / GE Engineering confirmed that the vendor drawings have not changed since the drawings were created
- GE Sourcing confirms vendor supplying correct parts
- GE design review confirms higher clearance is design intent, onsite measurements are indeed in-specification.
- GE factory inspections confirms higher clearance used on new unit assemblies across various frames
- GE Engineering confirms GE drawing discrepancy that leads to an incorrect expected clearance stack up

- Current/as-supplied bushings are acceptable for use
- NO Corrective Action for hardware required
- GE drawings being revised to correct bushing ID discrepancy
- IGV Backlash setting controlled by back-shimming the rack per standard assembly instructions
