ExxonMobil Baytown Frame 6B TIL 1576 EOL Inspection Results

Frame 6B User Group Meeting
June 25-28, 2012
Greg Polasek

Baytown Cogen Vital Stats

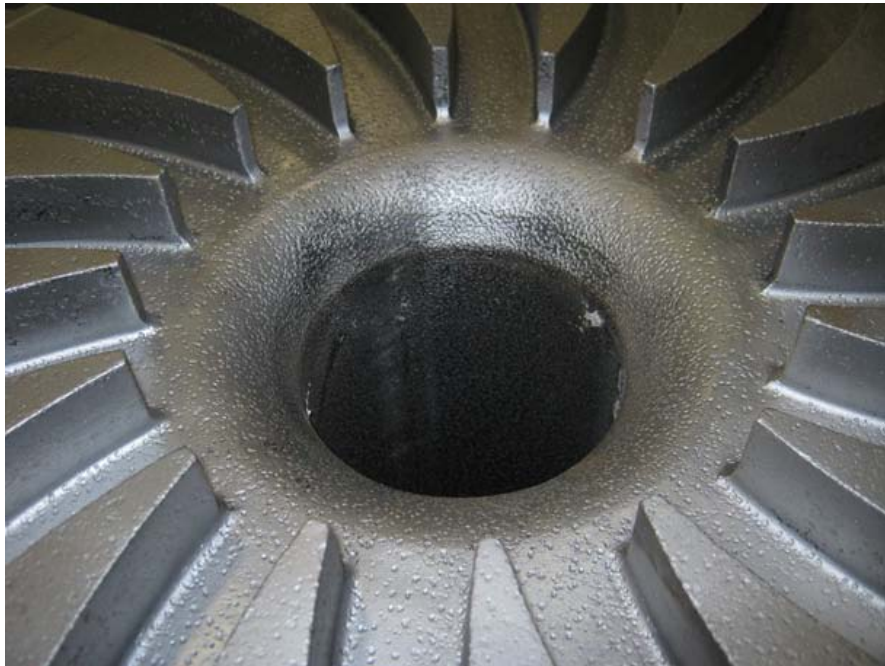
Visual Inspection and Replications

- Pitting in the bore, throughout cooling air flow surfaces on compressor 16th stage thru stage 2 turbine wheel
- Pitting generally noted on all wheels, nothing life limiting to the components; no micro-cracking or grain structure variations documented from any of the replicas
- Bore surfaces were reconditioned / honed to eliminate stress concentrations and bore fatigue damage

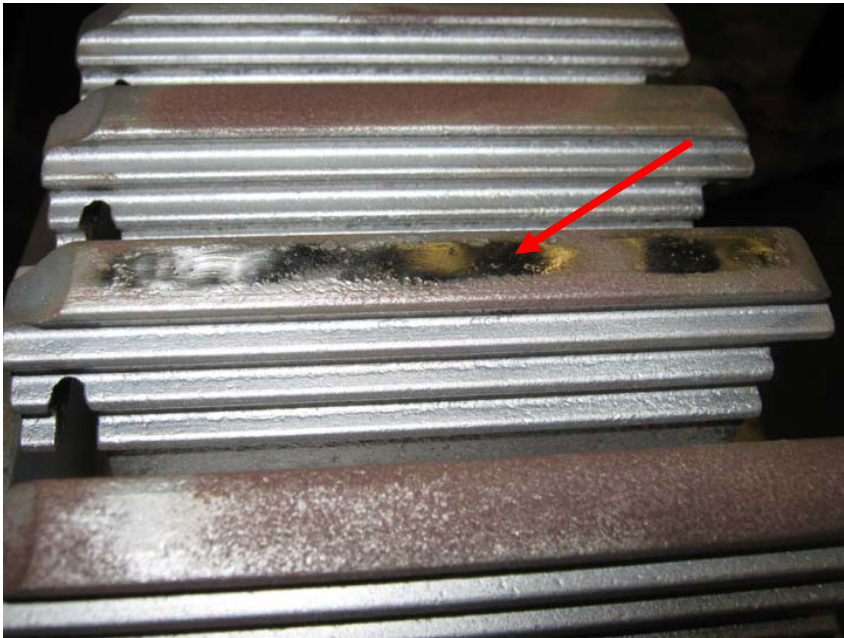
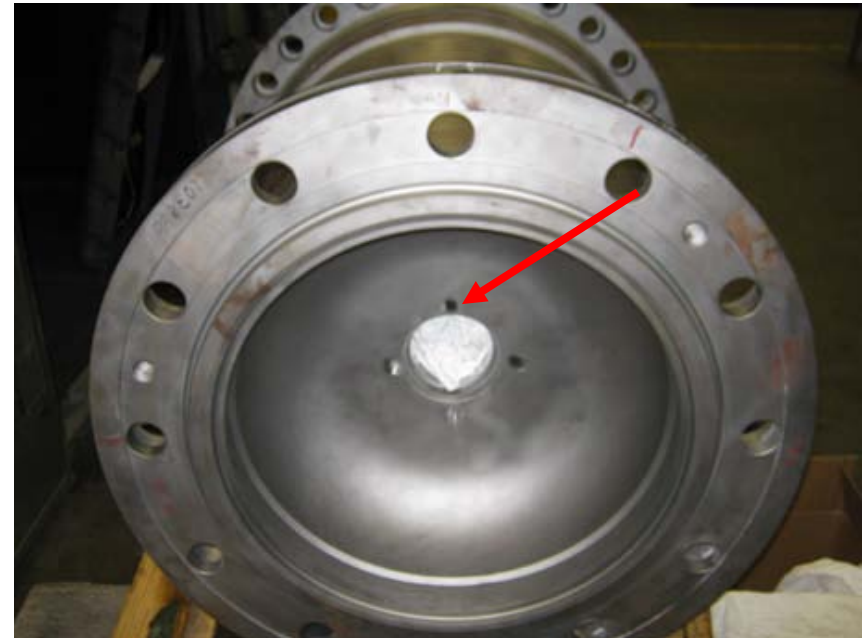
Hardness readings – all within GE's serviceable tolerance ranges, no concerns

- Taken on rim and hub regions
- Wide variations found, consistent with GE experience as hardness readings through the life of the component are required to understand true material degradation
- Reviewed against forging records, no values which would have an impact on the component life through the extended life

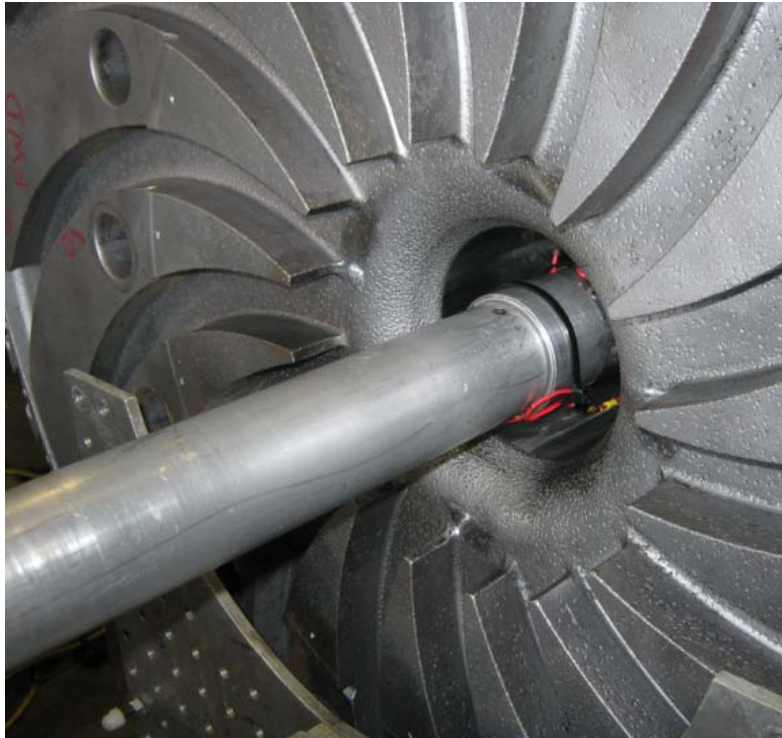
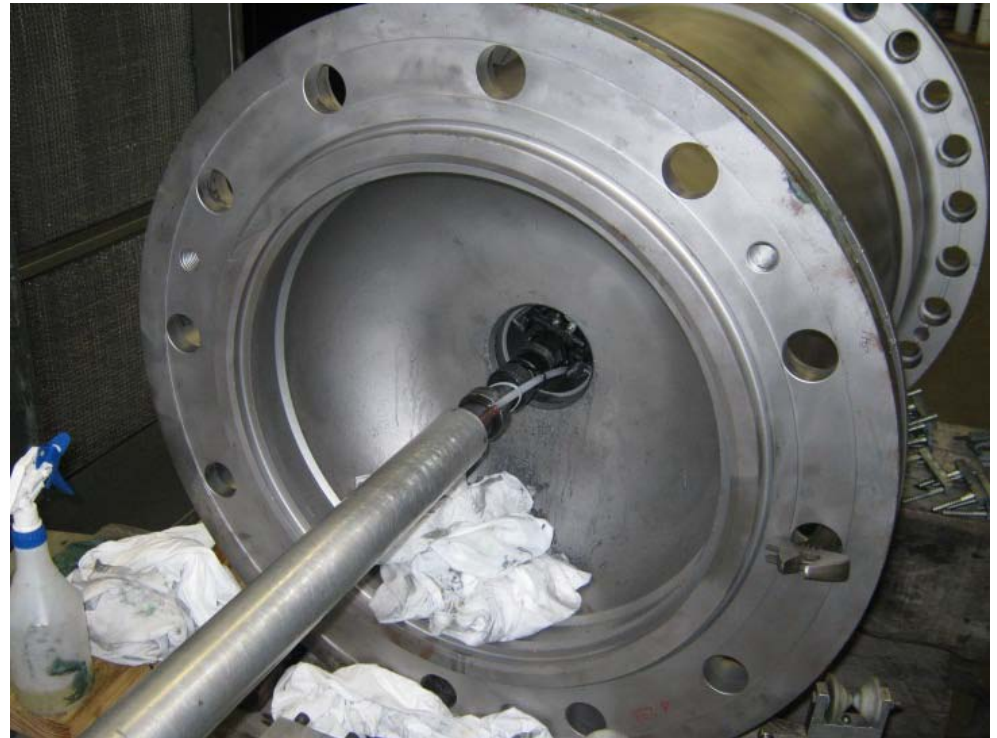
Ultrasonic readings – no life limiting findings

- Performed on bore surfaces of all components in scope.
- Some indications were found imbedded into the distance piece. The defects were most likely original imperfections in the original forgings. Fracture assessments determined no anticipated propagations to failure within 750 starts.
