GTG24 S1S Cooling Holes

Cause of High 1AO Wheelspace Temperatures Since 2010 HGPI

Hunter Newby
April 11, 2012

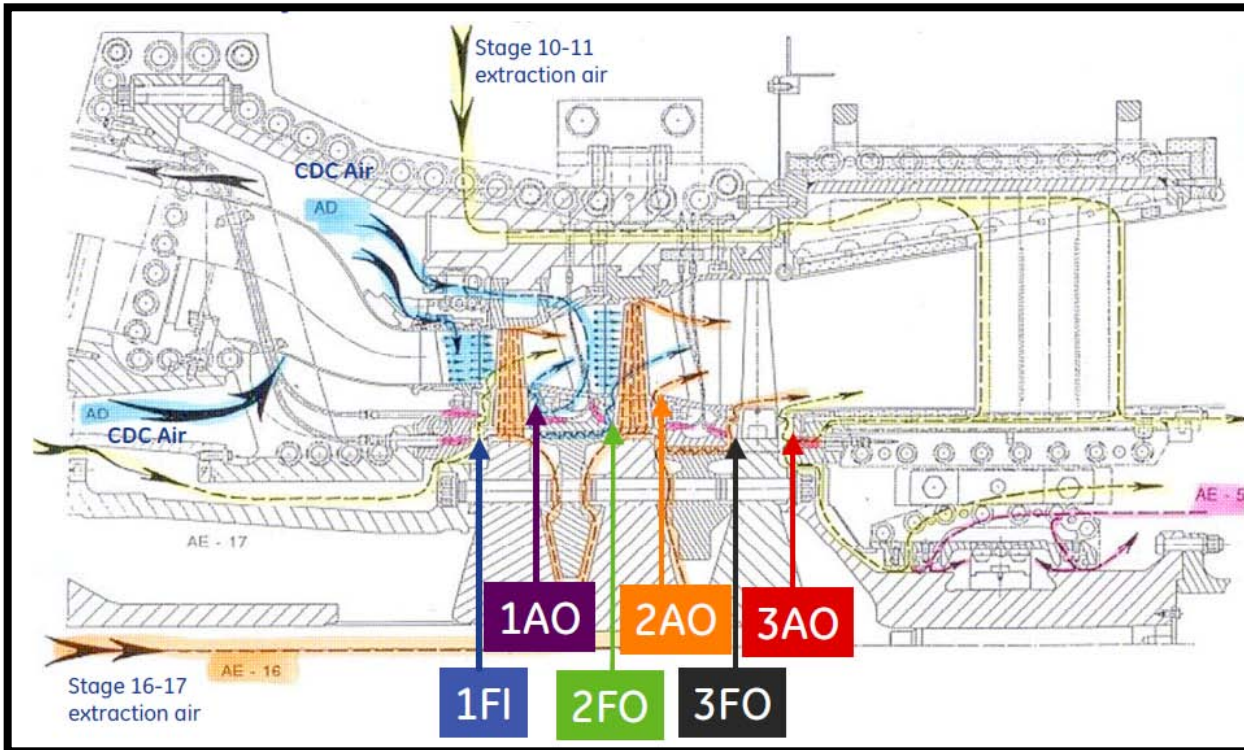
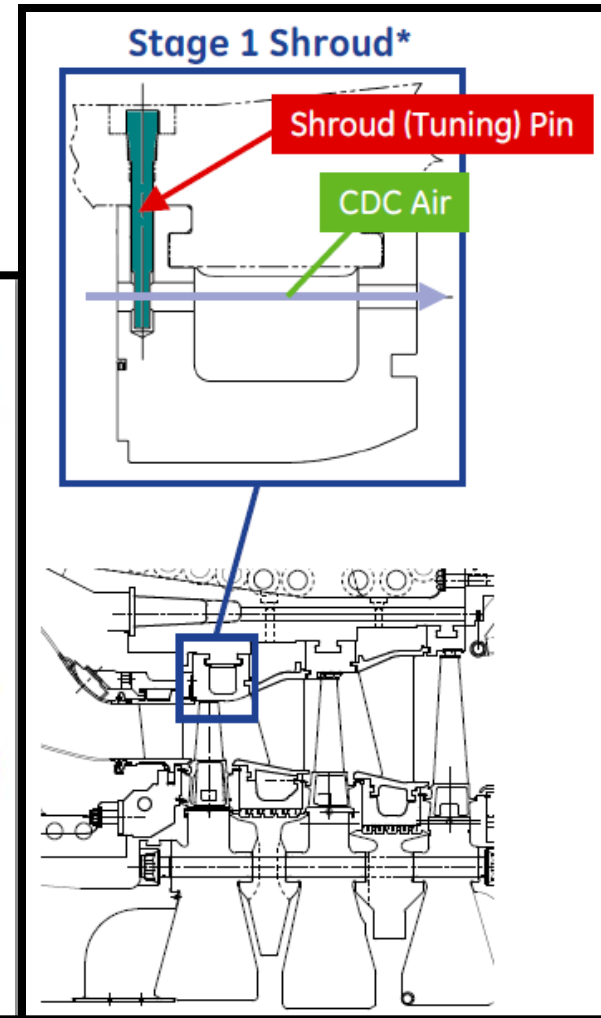
S1S/Tuning Pin Graphic

- S1S tuning pins are used to meter compressor discharge air from the CDC case to the 2nd stage nozzle
- S1S are shipped “blank”, hole locations are marked in the field to match the tuning pin holes in the casing, then drilled and installed

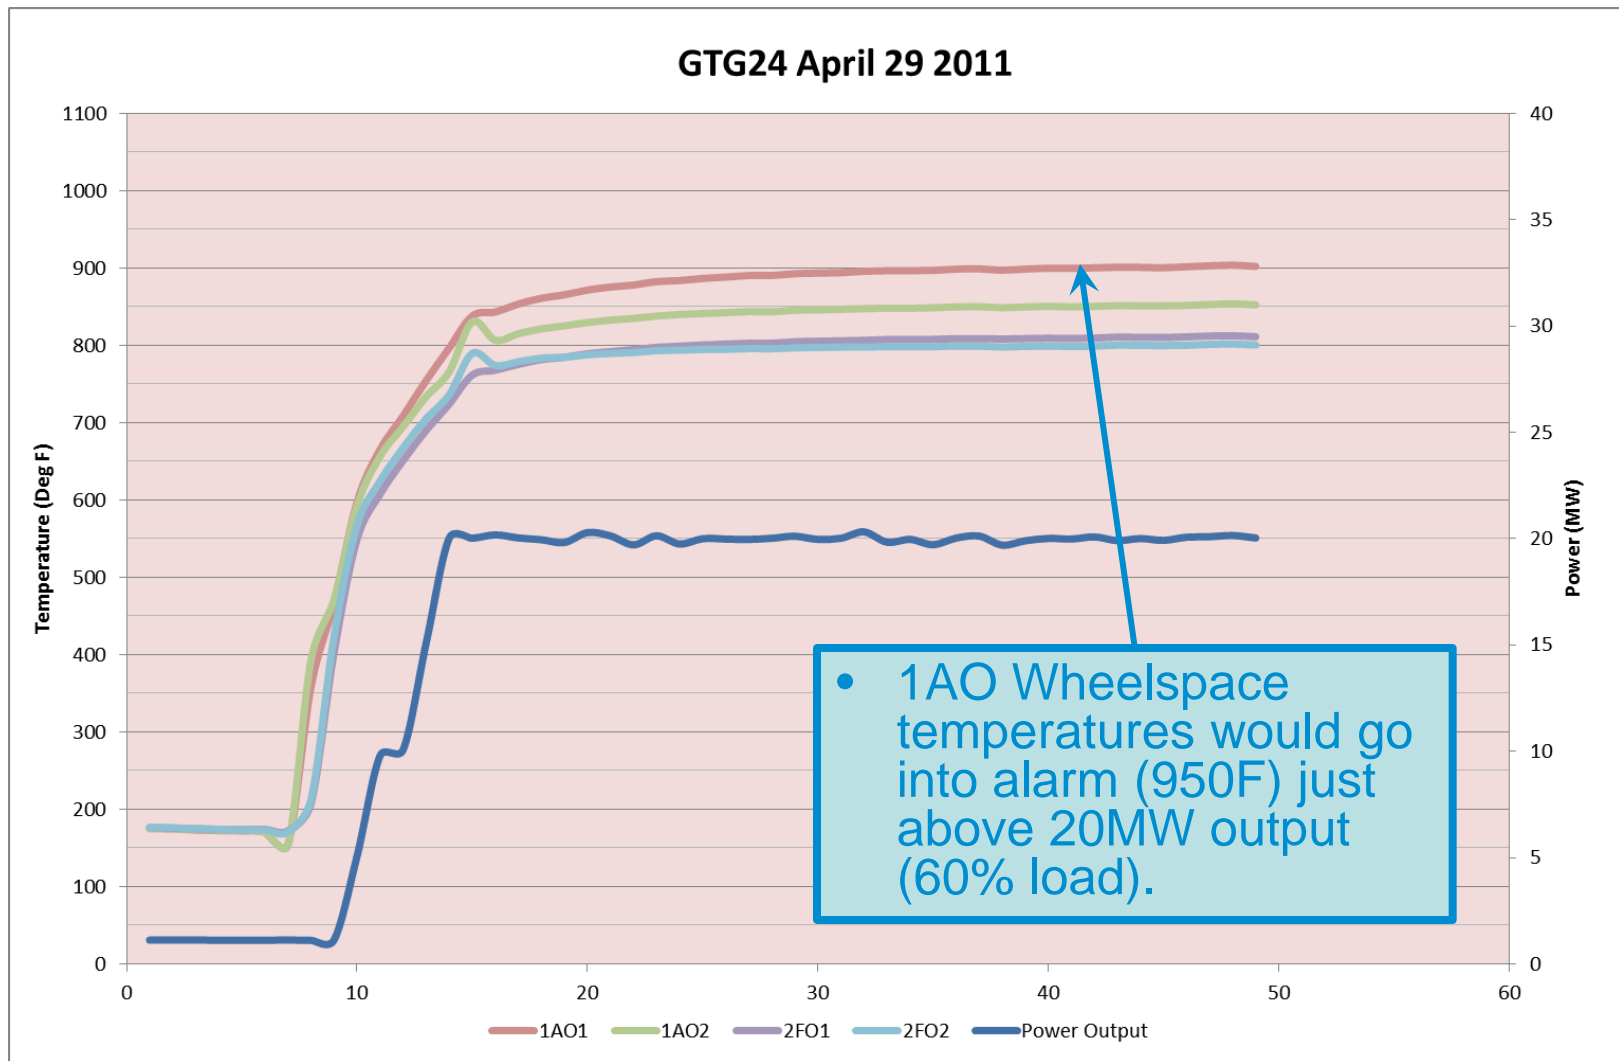
High 1AO Temps

- Location/Plant – Beaumont Refinery, Beaumont, TX
- COD 1992-1993 timeframe
- Base-load operation
- 2010 HGPI @ 124,700 hours
- 2010 HGPI included turbine destack and restack required to assess corrosion from a leaking deNOx steam valve during an extended outage. New S1S installed including custom-machining of about 20 shroud blocks due to casing ovalization.
- 2012 EBI/correction outage @ 135,900 hours

- PAC case entered after 2010 HGPI to aid high WST
 - Multiple exchanges with PAC resulted only in suggestions to replace WST thermocouples
 - 2011 EBI inspection showed no issues with the thermocouples
- S1S Tuning Pins
 - ExxonMobil requested GE to look at S1S tuning pins as a potential cause
 - Measured 0.498” dia pins during 2011 EBI inspection
 - GE records indicated 0.490” dia. Pins installed in the unit
 - PAC reevaluation of our design showed that the pins should be 0.475” dia.
- S1S Cooling Holes
 - 2012 EBI showed lack of S1S cooling holes – quality mistake by GE when installing new S1S during 2010 HGPI
 - Locating holes were marked and drilled, but not the cooling air holes
 - Turbine case removed, S1S holes drilled, and 0.475” pins installed
