BOP SGT-02

Frame 6B COGEN
IGV LVDT Misalignment/Wear

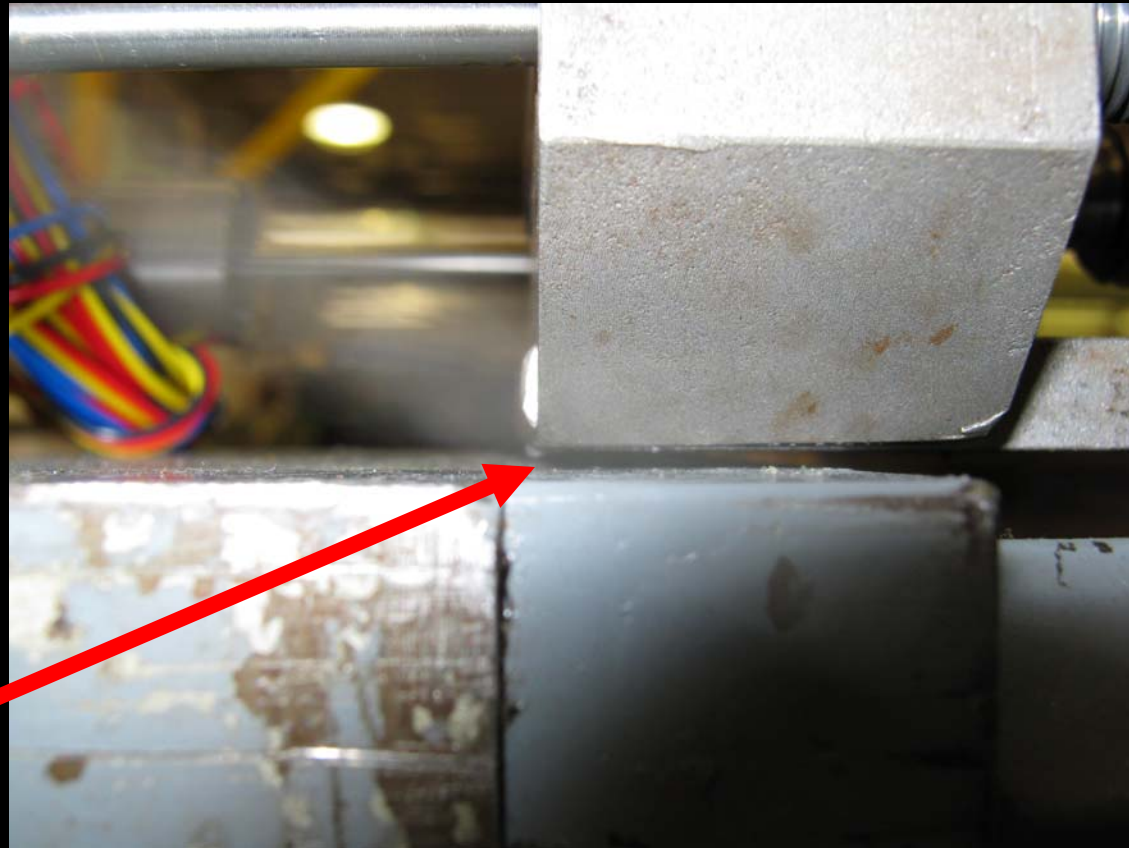
BOP Frame 6B IGV LVDT Wear

Clearance
issue on
(old)
actuator
guide

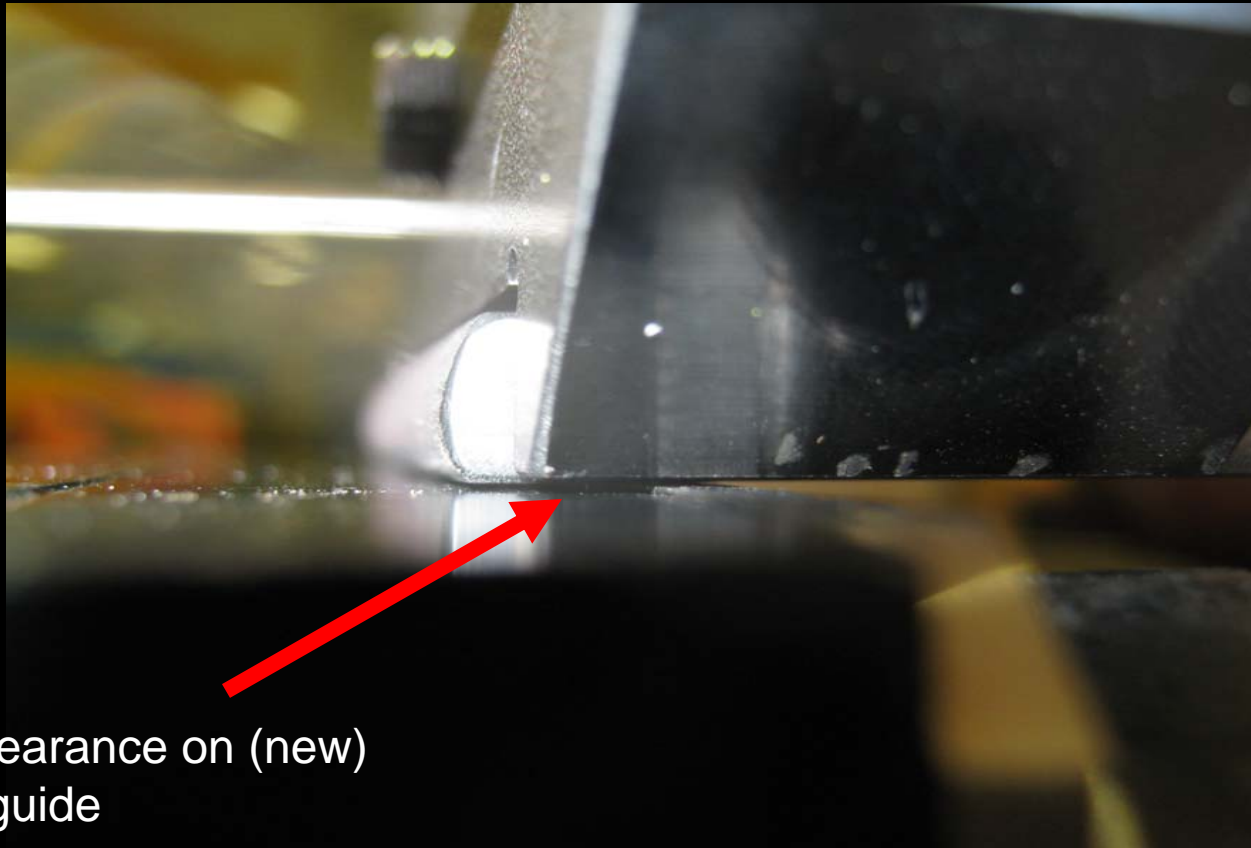
BOP Frame 6B IGV LVDT Wear

Tighter clearance on (new)
actuator guide
