# Fleet Updates

6B Users Conference | San Antonio, TX | June 19-22, 2017

# 6B Clashing update

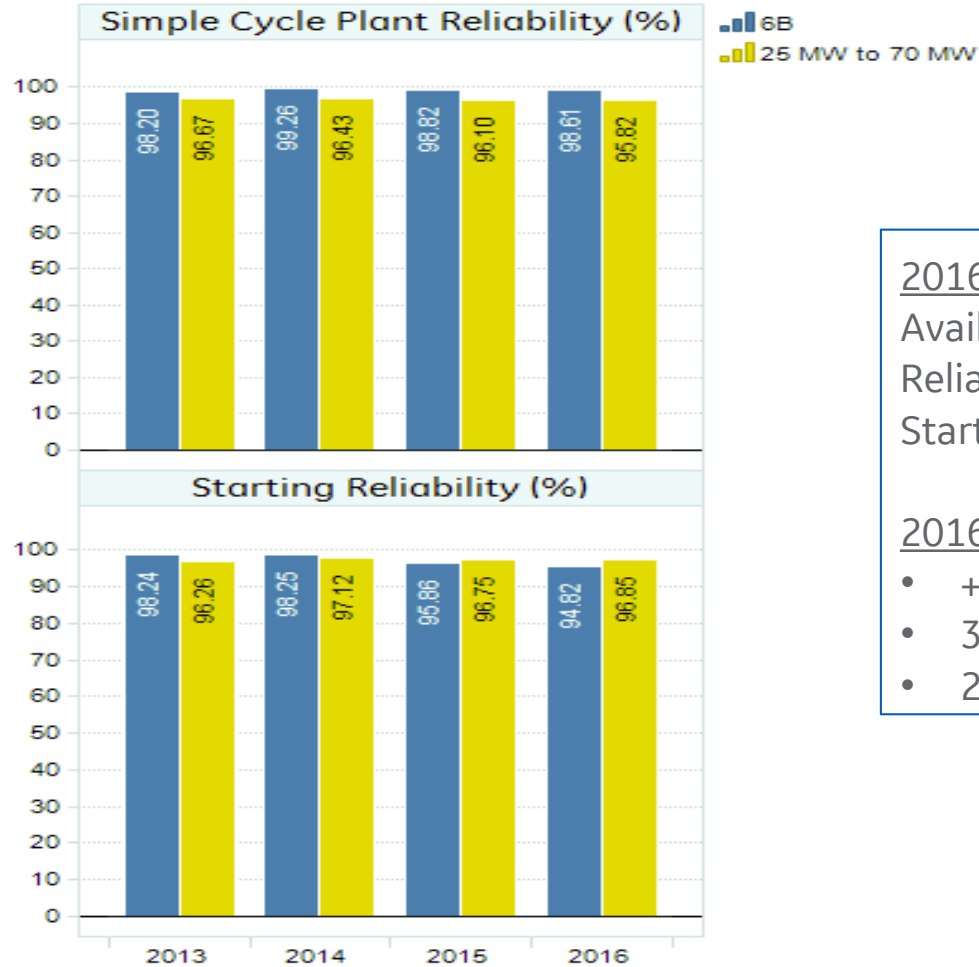
ORAP 4Q 2016 Report - 60 GE 6B units & 267 Industry units (including GE units)

2016 - GE 6B Fleet RAM Highlight  
 Availability : 91.43%  
 Reliability : 98.61%  
 Starting Reliability : 94.82%

- +9 days more available for service
- 3% pt. higher in Reliability
- 28% higher in MTBF

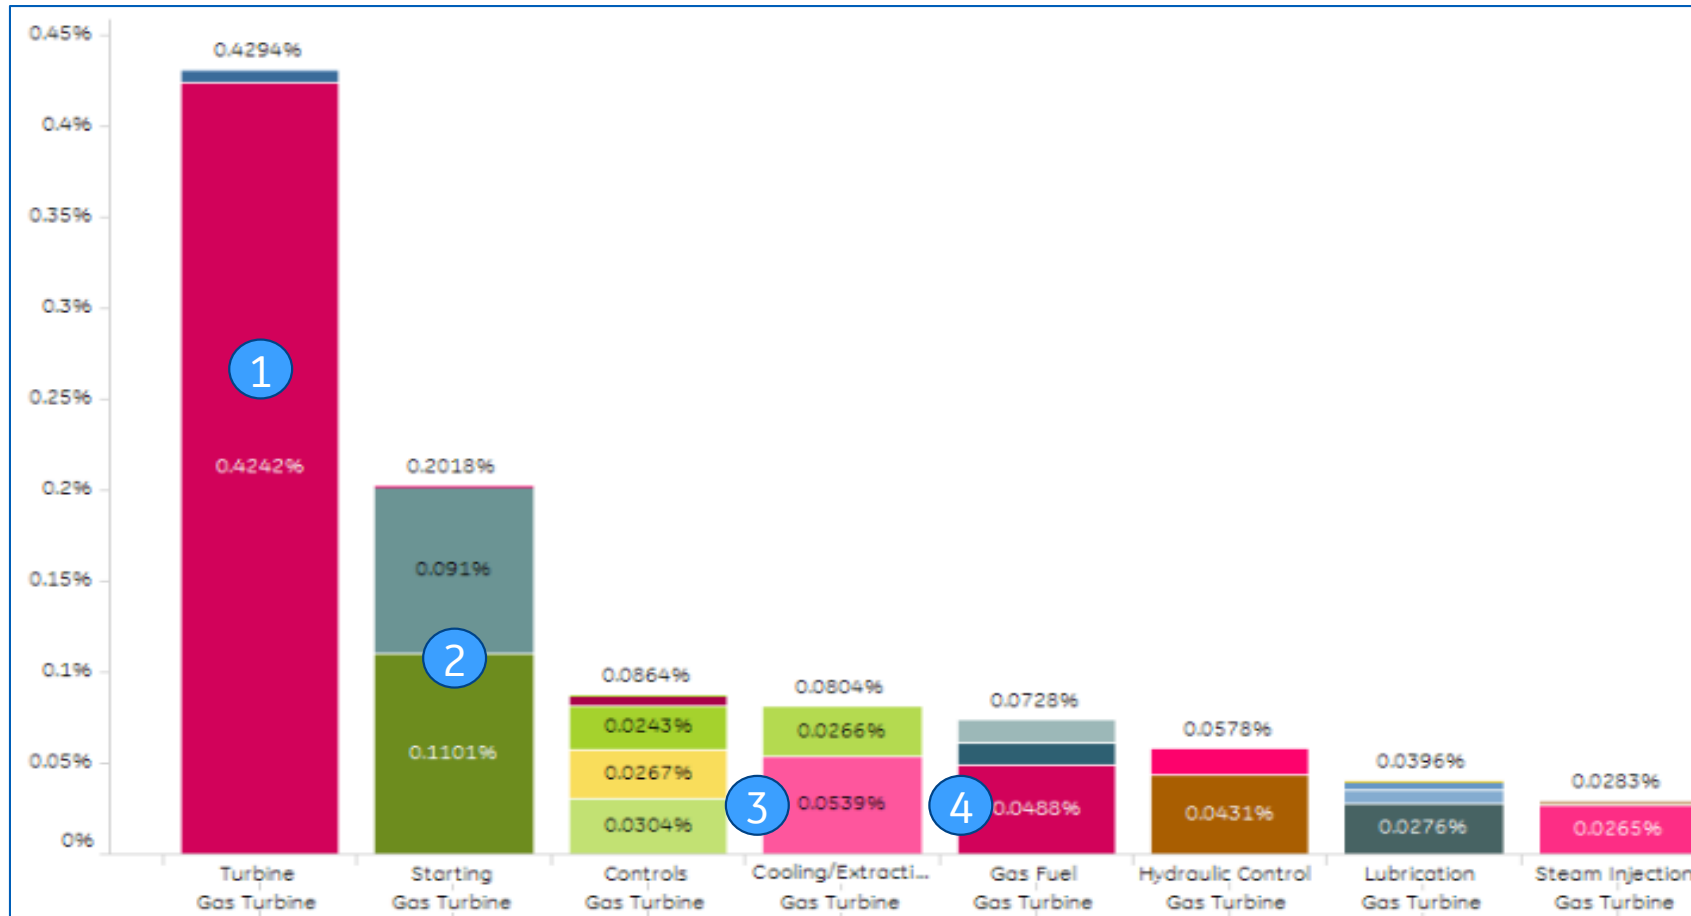
2016 Events as reported via ORAP

1. GT Turbine Rotor
2. GT Starting Motor/Engine/Transmission
3. GT Cooling Extraction Air Valves
4. GT Gas Fuel Valves
